Office of the Chief Investigator
Transport Safety

**Rail Safety Investigation
Report № 2011 / 02**

**End of Track Overrun
MTM Train 4506
Carrum Siding
03 March 2011**

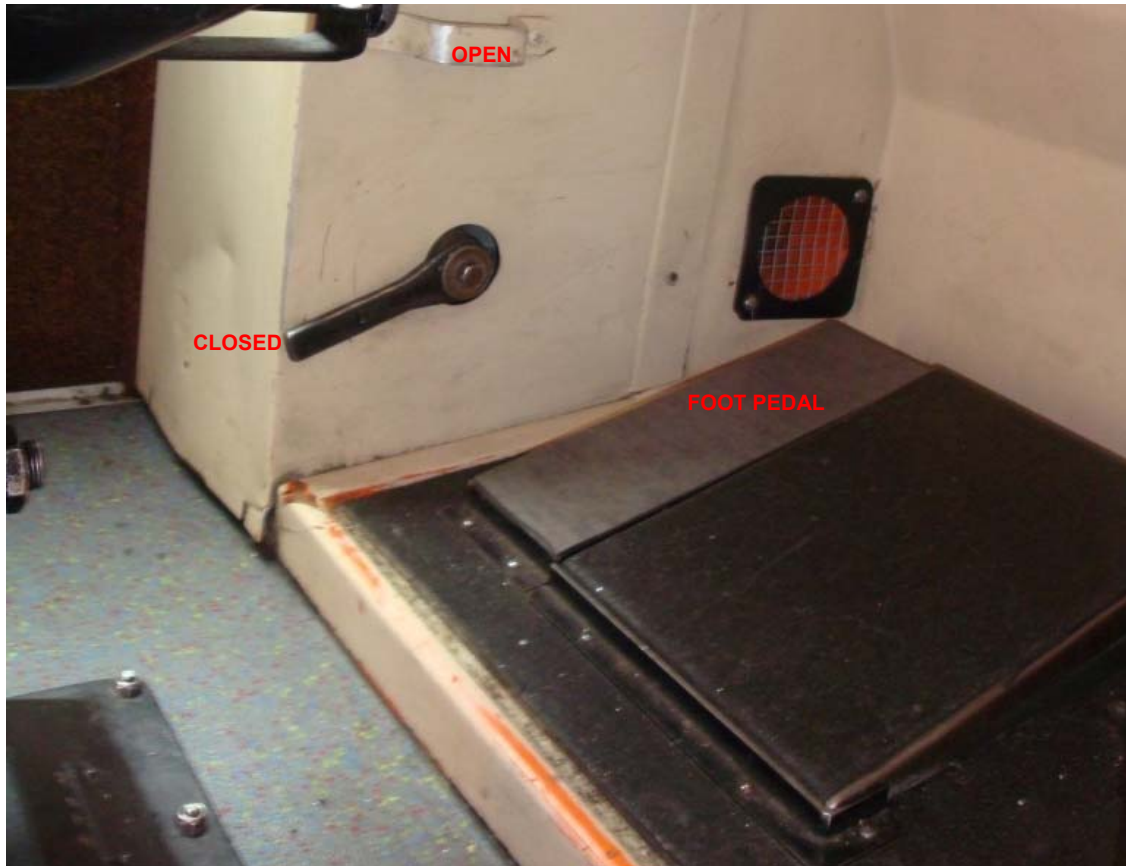
BVICS: The BVICS operating lever is located below the driving console adjacent to the driver's left leg (see Figure 3). When this device is closed it cuts off the air supply to the brake pipe and all connections to the Brake Controller, rendering the rheostatic, electro-pneumatic and pneumatic brakes inoperative. In this position only emergency air braking is operative. The BVICS operating lever must be in the 'Open' position in the activated cab for the brake system to operate.

Figure 3 - Comeng train BVICS (in 'Closed' position)

A characteristic of Comeng trains is that the driver can apply traction power despite the braking system being de-activated when the BVICS is closed in such a manner that a residual air pressure of at least 325 kPa is retained in the brake pipe.

The only safeguard against the train being operated when the air brake system is isolated after de-activation of a driving cab is by the action of the driver exhausting the brake pipe prior to closing the BVICS (in accordance with the operating procedure). In this instance the Frankston to Carrum driver did not follow the correct procedure.

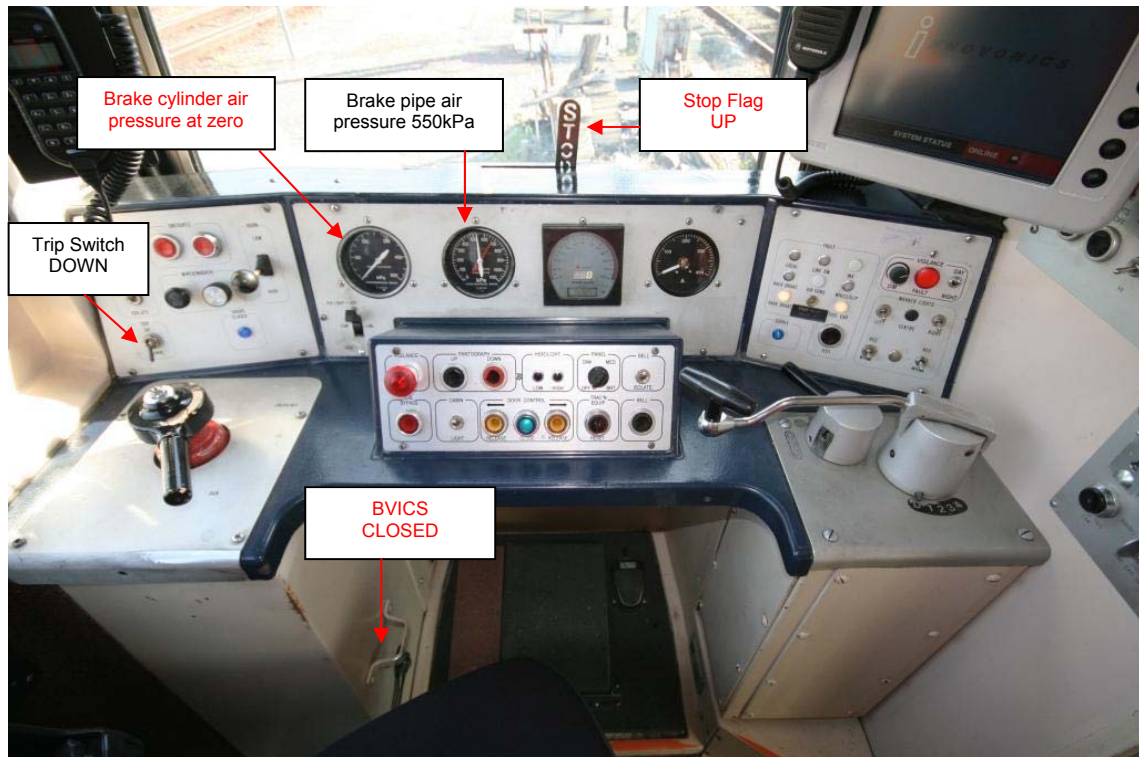
The driver stated that when the train arrived at Carrum railway station, he entered the trailing cab (323M), sat in the driver's seat and noticed that the Trip Switch was down and the brake pipe air pressure was displaying 550 kPa. He did not notice that the Brake Cylinder Air Pressure Gauge read zero, the Stop Flag was raised, and that the BVICS was closed.

Figure 5 - Status of 323M driving cab console at Carrum when taken over by the relief driver. Items not noticed by the relief driver are in red.

When he entered the driver's cab the incident driver noticed that the Trip Switch had been left in the 'Down' position. Had the previous driver followed the required procedure and raised the switch when changing ends at Frankston, the incident driver might not have assumed that the train was ready to be driven.

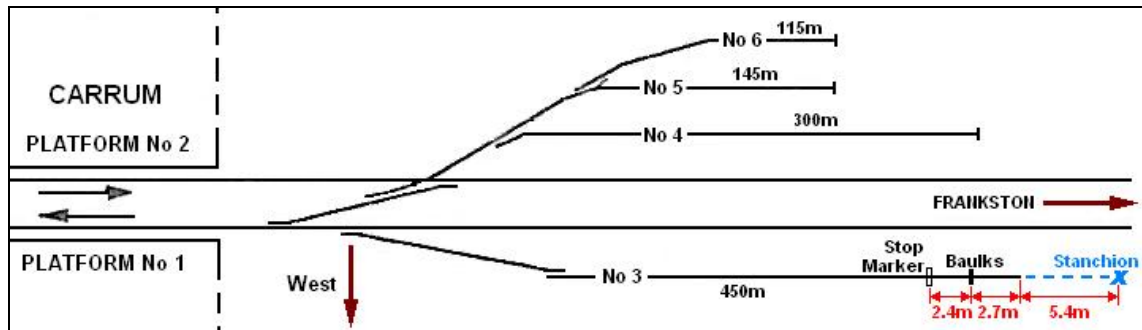
Figure 6 - Diagram of Carrum sidings.

At No 3 siding, the Stop Marker⁴ was located 2.4 metres prior to the baulks and the track ended 2.7 metres beyond the baulks. The stanchion supporting the overhead wire was located 5.4 metres beyond the end of the track, or 8.1 metres beyond the baulks. The train came to a stop about 10.8 metres beyond the baulks.

In this incident, the baulks provided at the end of the line were unable to stop a train travelling at 18 km/h from derailing and colliding with the steel stanchion. The steel stanchion at the end of № 3 siding was supporting the overhead contact wire and after the collision the contact wire became dislodged and fouled the main line.
