Office of the Chief Investigator
Transport Safety

**Marine Safety Investigation
Report No 2012/04**

**Fire Aboard
Fishing Charter Vessel Bluefin II
Southeast of Cape Nelson Portland
7 July 2012**

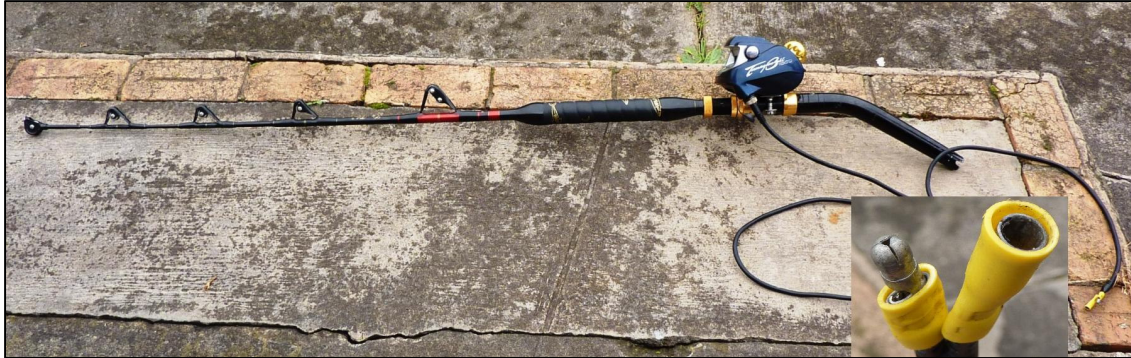
Figure 3: Electric fishing reel and connectors

The manufacturer of the electric reels does not provide any information on specific installation requirements or overcurrent protection devices required when powered by a vessel's power supply. However, the operating manual for the reels state that they are made to operate on a 12 volt dc supply and that 'power supplied by a boat can be unstable' and recommends that a battery pack provided by Daiwa is used with the reel. Further, the manual states that the reel incorporates a circuit breaker system that is designed to stop the automatic winding function should there be an excessively heavy load. Daiwa was unable to provide further information on this protection system.

Witness accounts indicate that smouldering and sparking was initially observed in at least two areas. The smouldering was observed at or in the vicinity of the junction box where the electric fishing reel circuit was connected. Sparking was also observed at the point where the reel connectors were plugged into the 12V reel supply circuit.

When the reel snagged, a relatively high current of around 10 amperes (stall current) would have resulted. As the vessel was being manoeuvred to free the line, the rotor of the electric reel was probably forcibly rotated in opposition to the torque generated by the motor attempting to wind in the reel. This action may have resulted in a current in excess of 10 amperes and potentially up to 30 amperes. Had the reel been cut as soon as the line snagged on the bottom, these higher currents would have been avoided.

It is probable that poor contact or corrosion at circuit connections in the presence of the high current generated sufficient heat to breakdown the cable insulation resulting in ignition. It is probable this would have then led to the short circuiting of conductors and even higher currents. These resulting high current should have tripped the protection circuit breaker. It is apparent that the short circuit current was sustained for a sufficient period for ignition to occur at multiple locations in the circuit and ignite surrounding materials including the flammable FRP hull material.
