Office of the Chief Investigator
Transport and Marine Safety Investigations

Rail Safety Investigation

Brief Report

Train Impact with Passenger

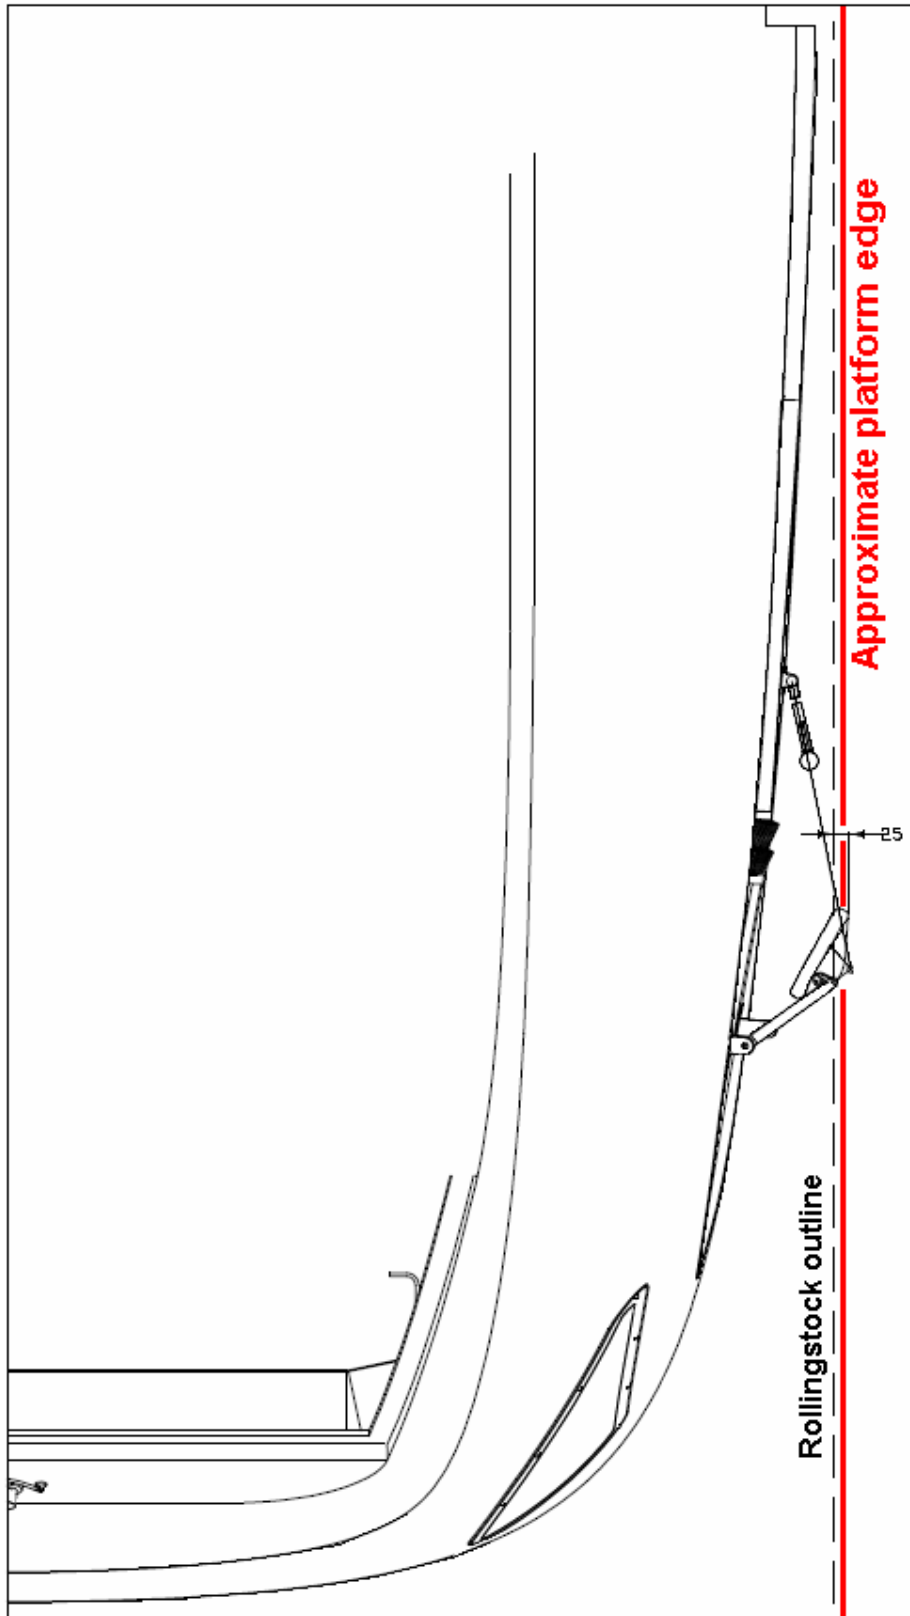
Appendix 3

The VLocity DMU (Diesel Multiple Unit) railcar comprised two semi-permanently-coupled cars. The driver's cabs — one at each end — are fitted with exterior, truck-type rear-vision mirrors located one on either side of the cabin. These protrude about 25 mm outside of the vehicle maximum width dimension when the mirrors are deployed to the normal extent required for operation. In this position, the mirrors only barely project across the platform edge, if at all. This minimal degree of overhang beyond the relevant rolling-stock and infrastructure maximum outlines is permitted and is well clear of the 'warning' area defined by the yellow safety line.

Scale Diagram showing relationship of VLocity railcar outline to platform edge – plan view. Diagram indicates degree of overhang of rear-vision mirror (both outside of the maximum rolling-stock outline as well as over the platform edge) in normal service.

That V/Line consider — particularly when refurbishing or purchasing new rolling-stock — the provision of alternative arrangements or equipment configurations that would permit the removal of large exterior mirrors on Diesel Multiple Unit rolling-stock in regional passenger service.
