Office of the Chief Investigator
Transport Safety

**Rail Safety Investigation
Report № 2011 / 02**

**End of Track Overrun
MTM Train 4506
Carrum Siding
03 March 2011**

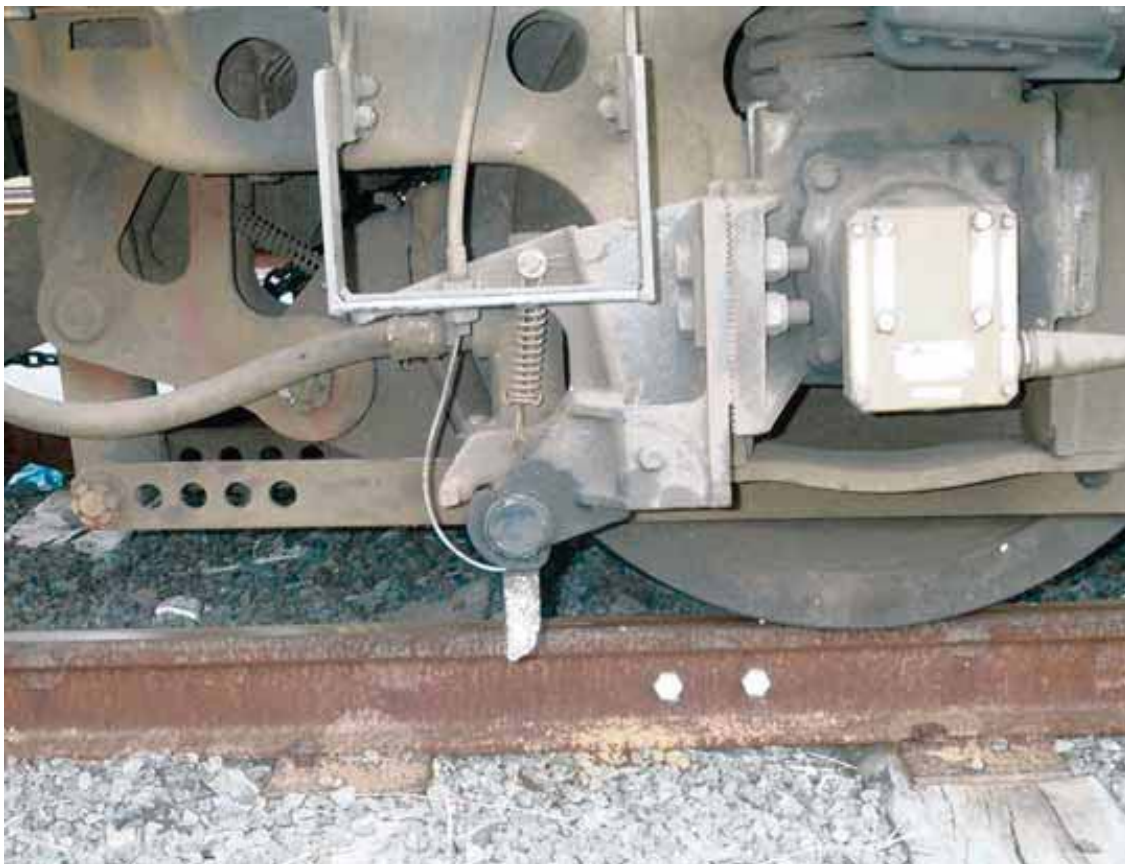
Figure 4 – Trip-lever in the lowered position

Trip-lever: The Trip-lever (see Figure 4) is installed adjacent to the leading left hand wheel (in the direction of travel) of the leading bogie of an 'M' car and is connected to a brake pipe vent valve. When a driving cab is active, the lever projects vertically downwards. If the Trip-lever is actuated an emergency brake application is made.
